Manhole Inspection Summary

Manhole # **S43GG_013MH**

Insp Date: **9/3/09 10:53 AM**

Location Address: **UNDER BRIDGE FOR R/R TRACKS** Cross Street: **BROADWAY**

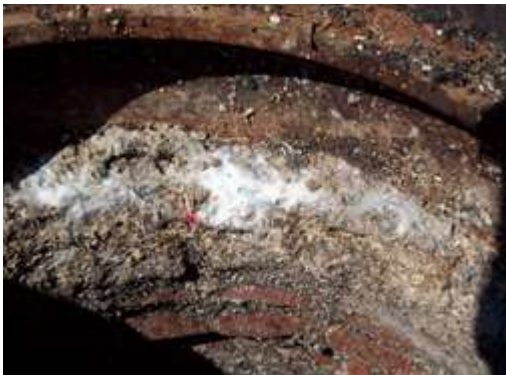
Defect 2

Comments **ALL LINES HAVE ACTIVE SURCHARGE WHEN BYPASS PUMP'S ARE' NT RUNNING**

Surcharge ☒ **Evidence Of Surcharge** Depth: **0.8** (ft.) ☒ **Active Surcharge Present**

EVIDENCE OF SURCHARGE

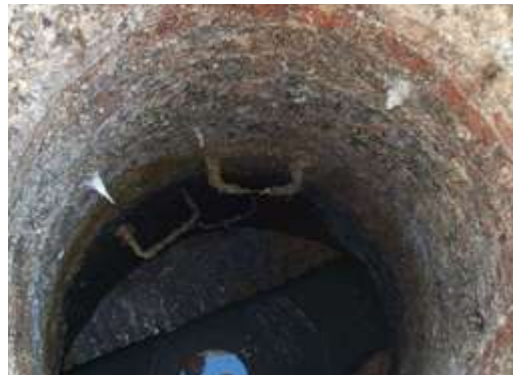
Defect 1

Steps Count: **5** Missing: **2** ☒ **Corroded**

CORRODED MISSING STEPS

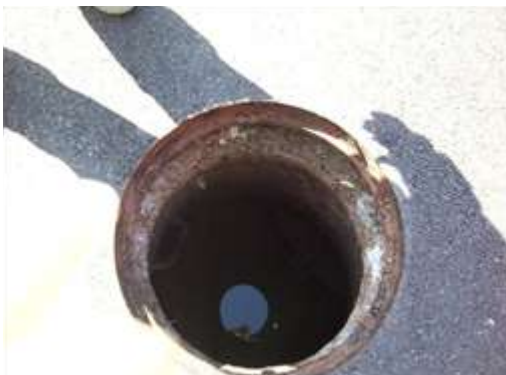
Defect 3

Frame Offset: **3** (in.) Condition: ☒ Sound ☐ Cracked ☐ Leaks

frame offset

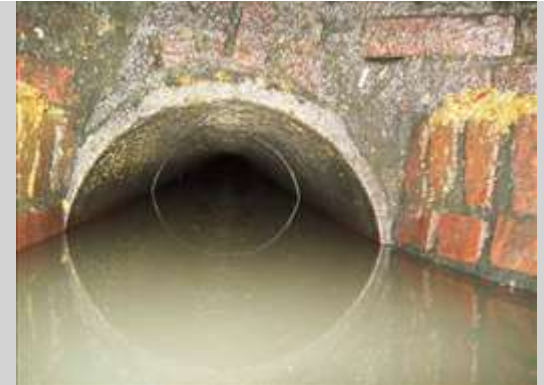
12 O'Clock Outflow

15 in. Circular Gravity Sewer
Pipe Out @ 12 O'Clock

Invert Depth: **10.60** (ft.) Flow Characteristics: **Slow**

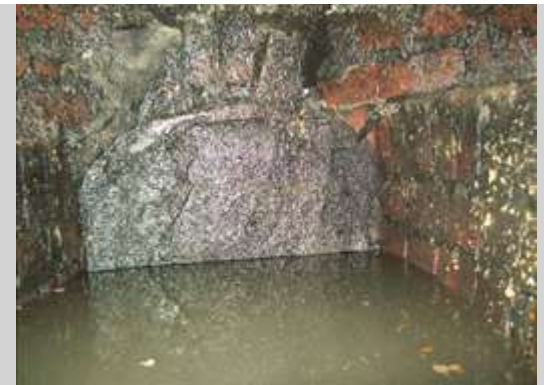
4 O'Clock Inflow

ABANDON LINE

Connects To: **Stub connection / abandoned**

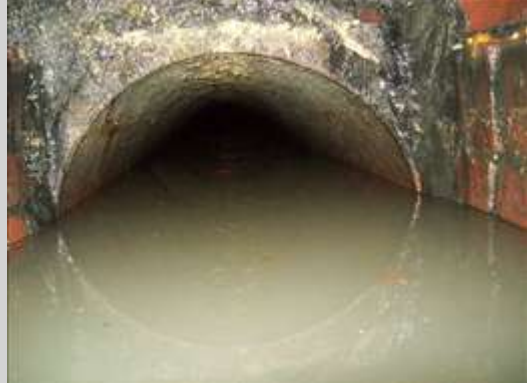
6 O'Clock Inflow

15 in. Circular Gravity Sewer
Pipe In @ 6 O'Clock

Invert Depth: **10.40** (ft.) Flow Characteristics: **Slow**
